Seismic Analysis And Retrofit Of Roosevelt Island Vertical Lift Bridge

**Beile Yin, PhD, P.E.
Nicholas J. Altebrando, P.E.
Frank M. Marzella, P.E.
Hardesty & Hanover, LLP**

TENTH BIENNIAL SYMPOSIUM

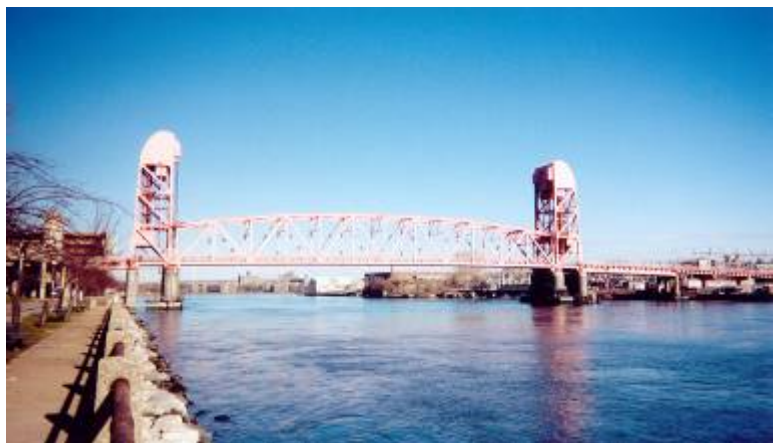
Roosevelt Island Bridge's main span, a vertical lift, presently carries one inbound lane, one outbound lane, and a sidewalk (see fig. 1). The 418-ft long lift-span was constructed from a Warren truss with a 5-in. open steel deck. The total length of the bridge is 936.5ft including the flanking spans and approach spans on the east and west side of the main span. There are

Fig. 1. Roosevelt Island Vertical Lift Bridge

two vertical towers, one on each side of the lift span, that carry the lift span and the counterweights. These two vertical lift towers rest on concrete piers. The piers supporting the lift span towers are concrete walls. The piers supporting the flanking spans are concrete multi-column piers, while the piers supporting the approach spans are steel hammerheads. The foundations of all piers are on bedrock except one of the east pier that is supported on steel H-piles.

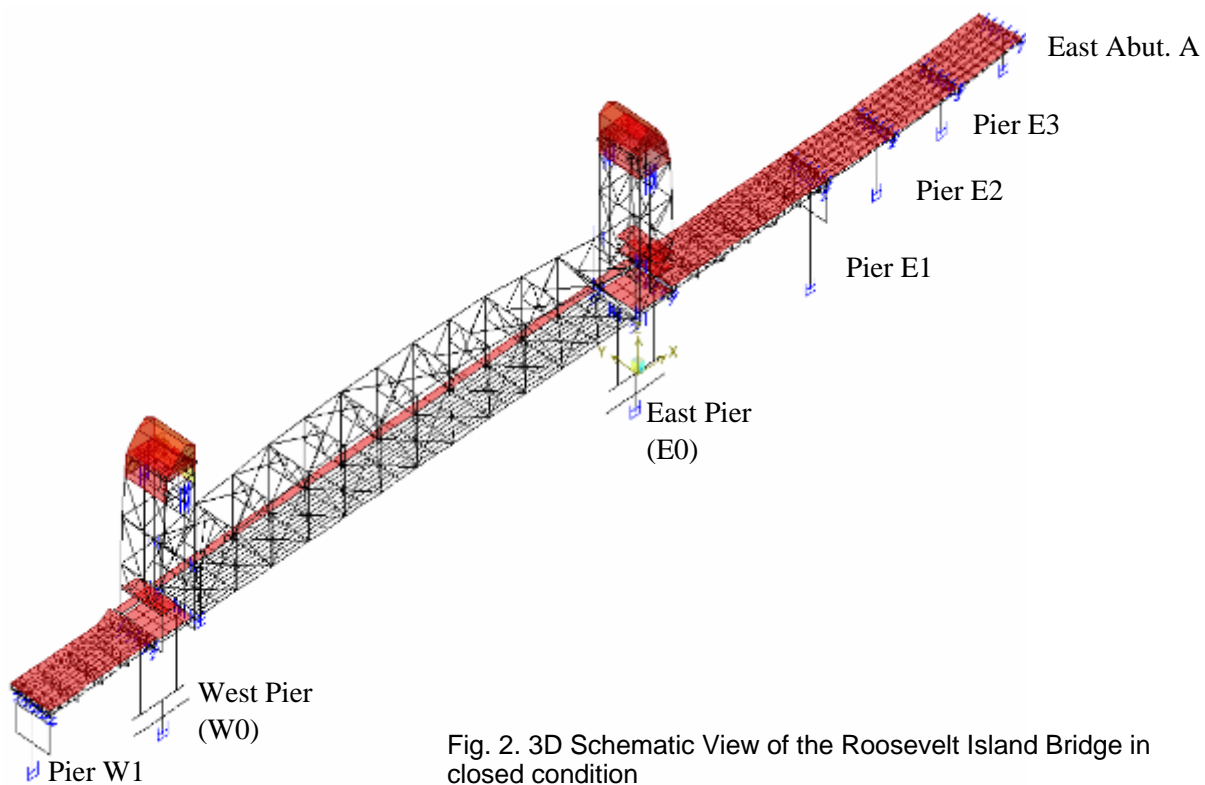
A three-dimensional, nonlinear dynamic analytical model of the Roosevelt Island Vertical Lift Bridge was built in SAP 2000 Nonlinear Version 8.1.5 (see fig. 2). The bridge superstructure was primarily constructed from beam and shell elements. Shell elements were used for modeling the deck for flanking and approach spans, and for metal sheet covering on the top of the towers. The existing steel and rocker bearings were modeled with linear link elements. The 5-in. open roadway grating on the lift span was considered to have no structural stiffness, however, the grating floor mass was included in the model. The counterweight was modeled as lump mass with both translational and rotational inertia. Also, the counterweight sheaves (large pulleys over which the cables passing from the counterweight to the span

Fig. 2. 3D Schematic View of the Roosevelt Island Bridge in closed condition

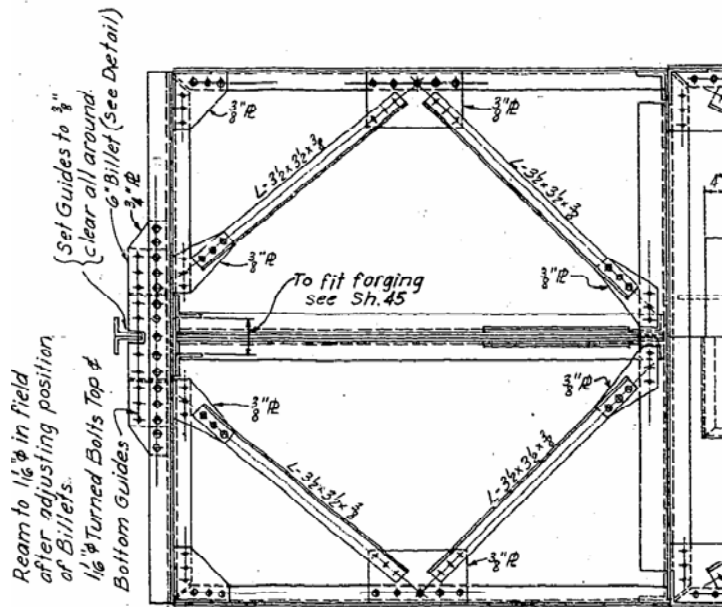
All non-linearity in the bridge is contained in the area around the counterweight. A gap of 3/8-in. is allowed on each side of the counterweight between the counterweight guide billet and the counterweight guide (see fig. 3). It is important to model small gaps because the forces are reduced for most of the duration of the earthquake due to the isolation effect. However, when contact is made between the counterweight and its guide, the velocity of the mass is high, and the ensuing impact causes larger forces to develop than if the counterweight is fully restrained. This gap between the counterweight and the counterweight guide is modeled with Non Linear Link Gap elements in SAP.

Fig. 3. Extract from Original Drawings Showing Counterweight Guide and Billet (Plan View)

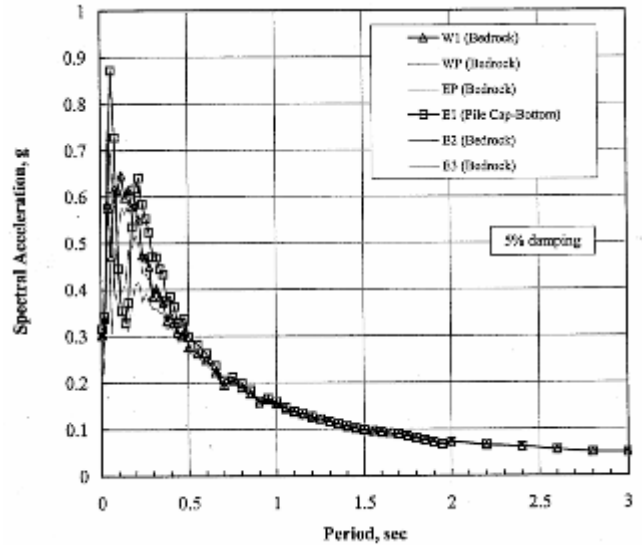
Analysis revealed that ground motions for all piers were almost similar with upper bound bedrock motion at Pier W1. Pier E1, resting on piles and embedded into soil and rock to significant length, showed spectrum of motion in the free-field at the elevation of the bottom of the pile cap that was significantly larger than that at the bed rock. But, the spectrum for Pier E1 was for free-field condition that ignored the soil-pile-pile cap interaction effect on the motion that the pile cap would experience. Figure 4 shows the comparison of the longitudinal component of spectra at the base of the footing on rock and at free field cap-bottom elevation of Pier E1 for a 2,500-year event. In order to conclude whether to use spectrum with single motion with three components or multi-support excitation SSI analysis using the motions appropriate for each pier foundation location, it was decided to perform a three-dimensional seismic analysis of the foundation of Pier E1 to compute the motion at the bottom of the massless pile cap and compare that outcome with the upper bound bedrock motions at Pier W1.

Fig. 4. Comparison of Spectra at Base of Footing on Rock and at Free-field Cap-bottom elevation of Pier E1 for 2,500-year Event, L-Component

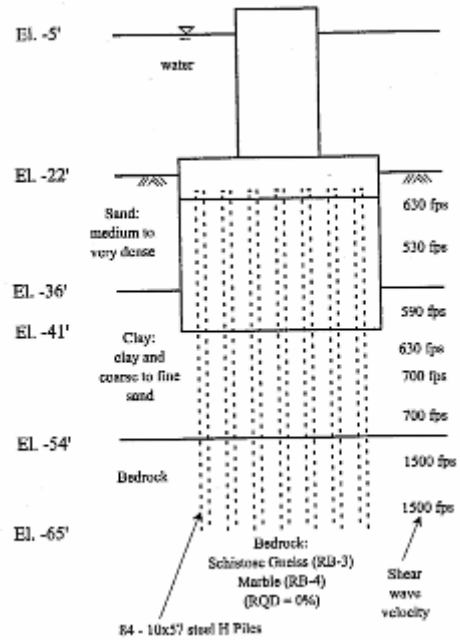
The three-dimensional seismic analysis of the soil-pile-pile cap system was performed using the computer program SASSI. Figure 5 shows the details of the soil profile and the pier foundation used in the analysis. The shear wave velocities shown in the figure correspond to the strain-compatible values that were computed from the ground motion analysis of the soil profile at Pier E1. Both longitudinal and transverse components of the bed rock motion at Pier E1 (computed from PROSHAKE) were used as input in the program SASSI, and the motions at the bottom of the massless cap were computed. The analysis result revealed that the spectra of the bedrock motion at Pier W1 (which envelop the spectra of all the other piers on bed rock) plot very closely to those of the cap-bottom motions at Pier E1. Hence, it was reasonable to use the bedrock motion of Pier W1 (in three components) as a uniform input motion at all the supports of the Roosevelt Island Bridge.

Fig. 5. Soil and Pile Foundation Details used in Seismic Analysis of Pier E1

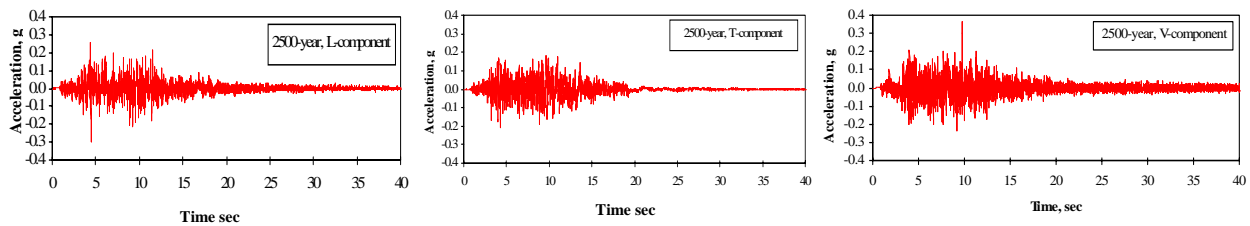
The seismic analysis of the bridge was performed for two levels of ground motions corresponding to 10% and 2% probabilities of exceedance in 50 years (approximately 500-year and 2,500-year events). Figure 6 shows 2,500-year time history ground motions used for the analysis of the Roosevelt Island Bridge.

Fig. 6. 2,500-Year Time History Ground Motions

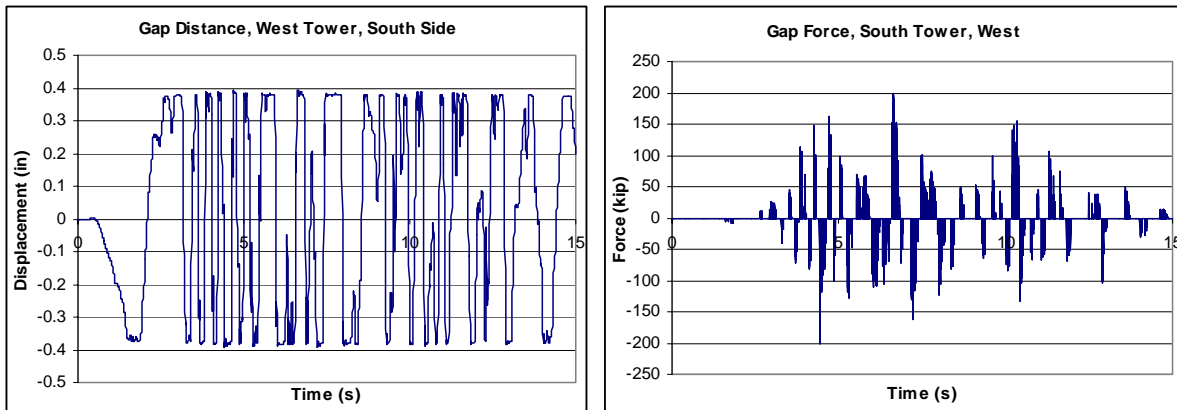
Displacement and force in the gap element are shown in figure 7. The force in gap element is from the counterweight on to the tower because of the small gap. It can be seen from these graphs that the force in the element is zero when the displacement is less than 3/8-in., and large peaks of force develop when the gap eventually closes.

Fig. 7. Displacement and Force in Gap Element

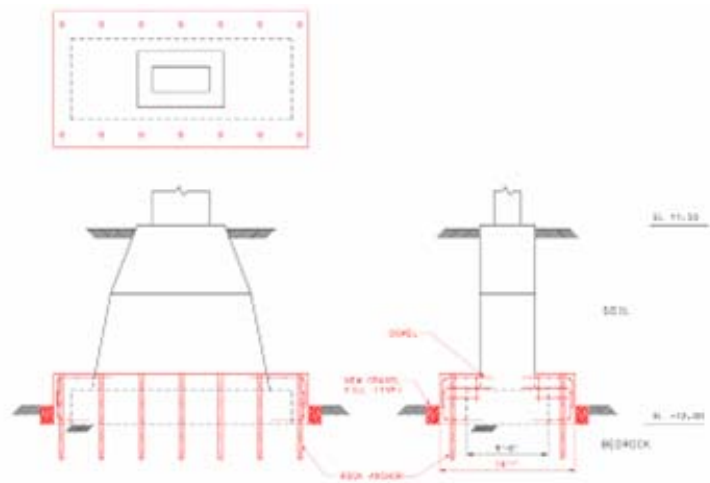
The foundations to Piers E2 and E3 were adequate for the 500-year event, but failed in overturning during the 2,500-year event. These foundations should be retrofitted with rock anchor set into the bedrock. Retrofit schemes for footing of Piers E2 are shown in figure 8. The counterweight guide and the top tower struts failed in both the 500- and 2,500-year events, however, no retrofit is required for these elements. The failure of these elements prevents the transfer of very high lateral loads to the adjacent structure and protects the rest of the structure; normal operation of the bridge will not be affected. The floor bracing to the lift span failed in the 2,500-year event, and should be replaced with larger members.

Fig. 8. Retrofit Scheme for Footing at Pier E2

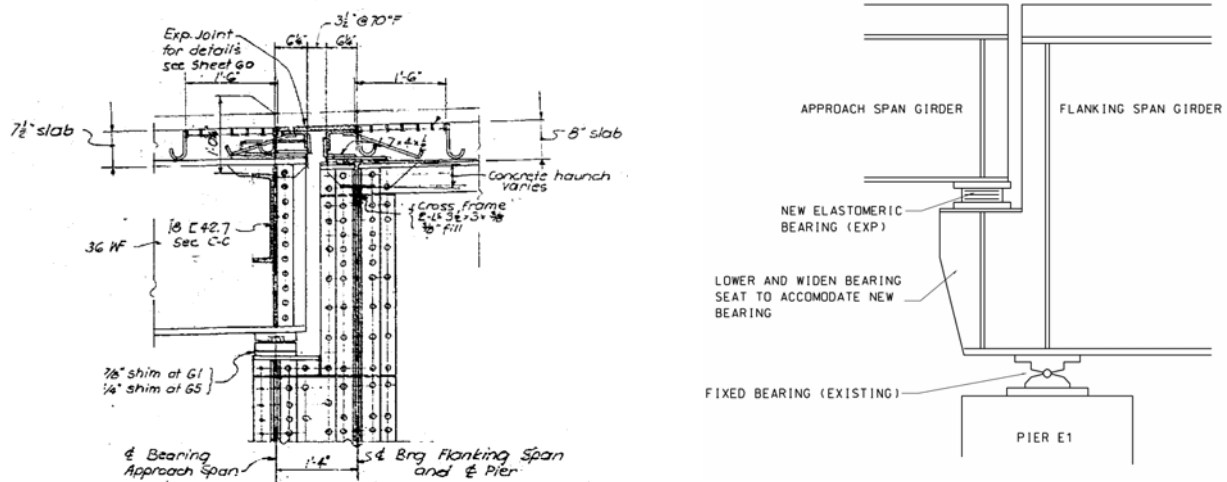
The rocker bearings supporting the flanking spans are functionally obsolete, and should be replaced with elastomeric bearings. The steel sliding bearings to the approach spans are functionally obsolete and should be replaced with elastomeric bearings. Also the bearing seats of steel-on-steel sliding bearings are not in accordance with AASHTO requirements and should be retrofitted. The fixed bearings to the approach spans should be replaced with elastomeric bearings because they will fail in the 2,500-year event. Scour and slope stability of the soil near Pier E1 will effect the future seismic performance of the pier. The retrofit scheme for the bearing seat at the approach span at Pier E1 and the retrofit summary for elements of the bridge vulnerable to seismic event are shown in figures 9 and 10, respectively.

Fig. 9. Extract from Original Drawings and the Retrofit Scheme for Bearing Seat at Pier E1

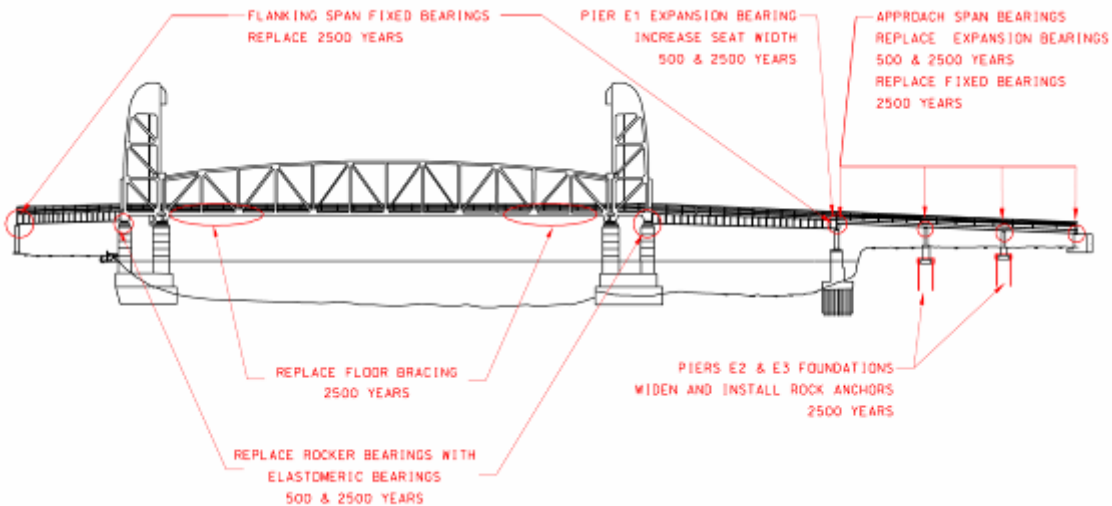
Fig. 10. Retrofit Summary for Components of the Bridge Vulnerable to Seismic Event
